UNIVERSITY OF CALIFORNIA LICK OBSERVATORY		TV AC POWER INTERRUPT BOX DEIMOS SPECTROGRAPH	
DES'N BY: B. Alcott	ORIGIN DATE: 01-02-01	DWG. NO.	NUM. 1 OF 1
Last SN	MODIFY DATE: 09-17-01	EL-3013	
PATH: DEIMOS/TVINTERRUPT	REVA

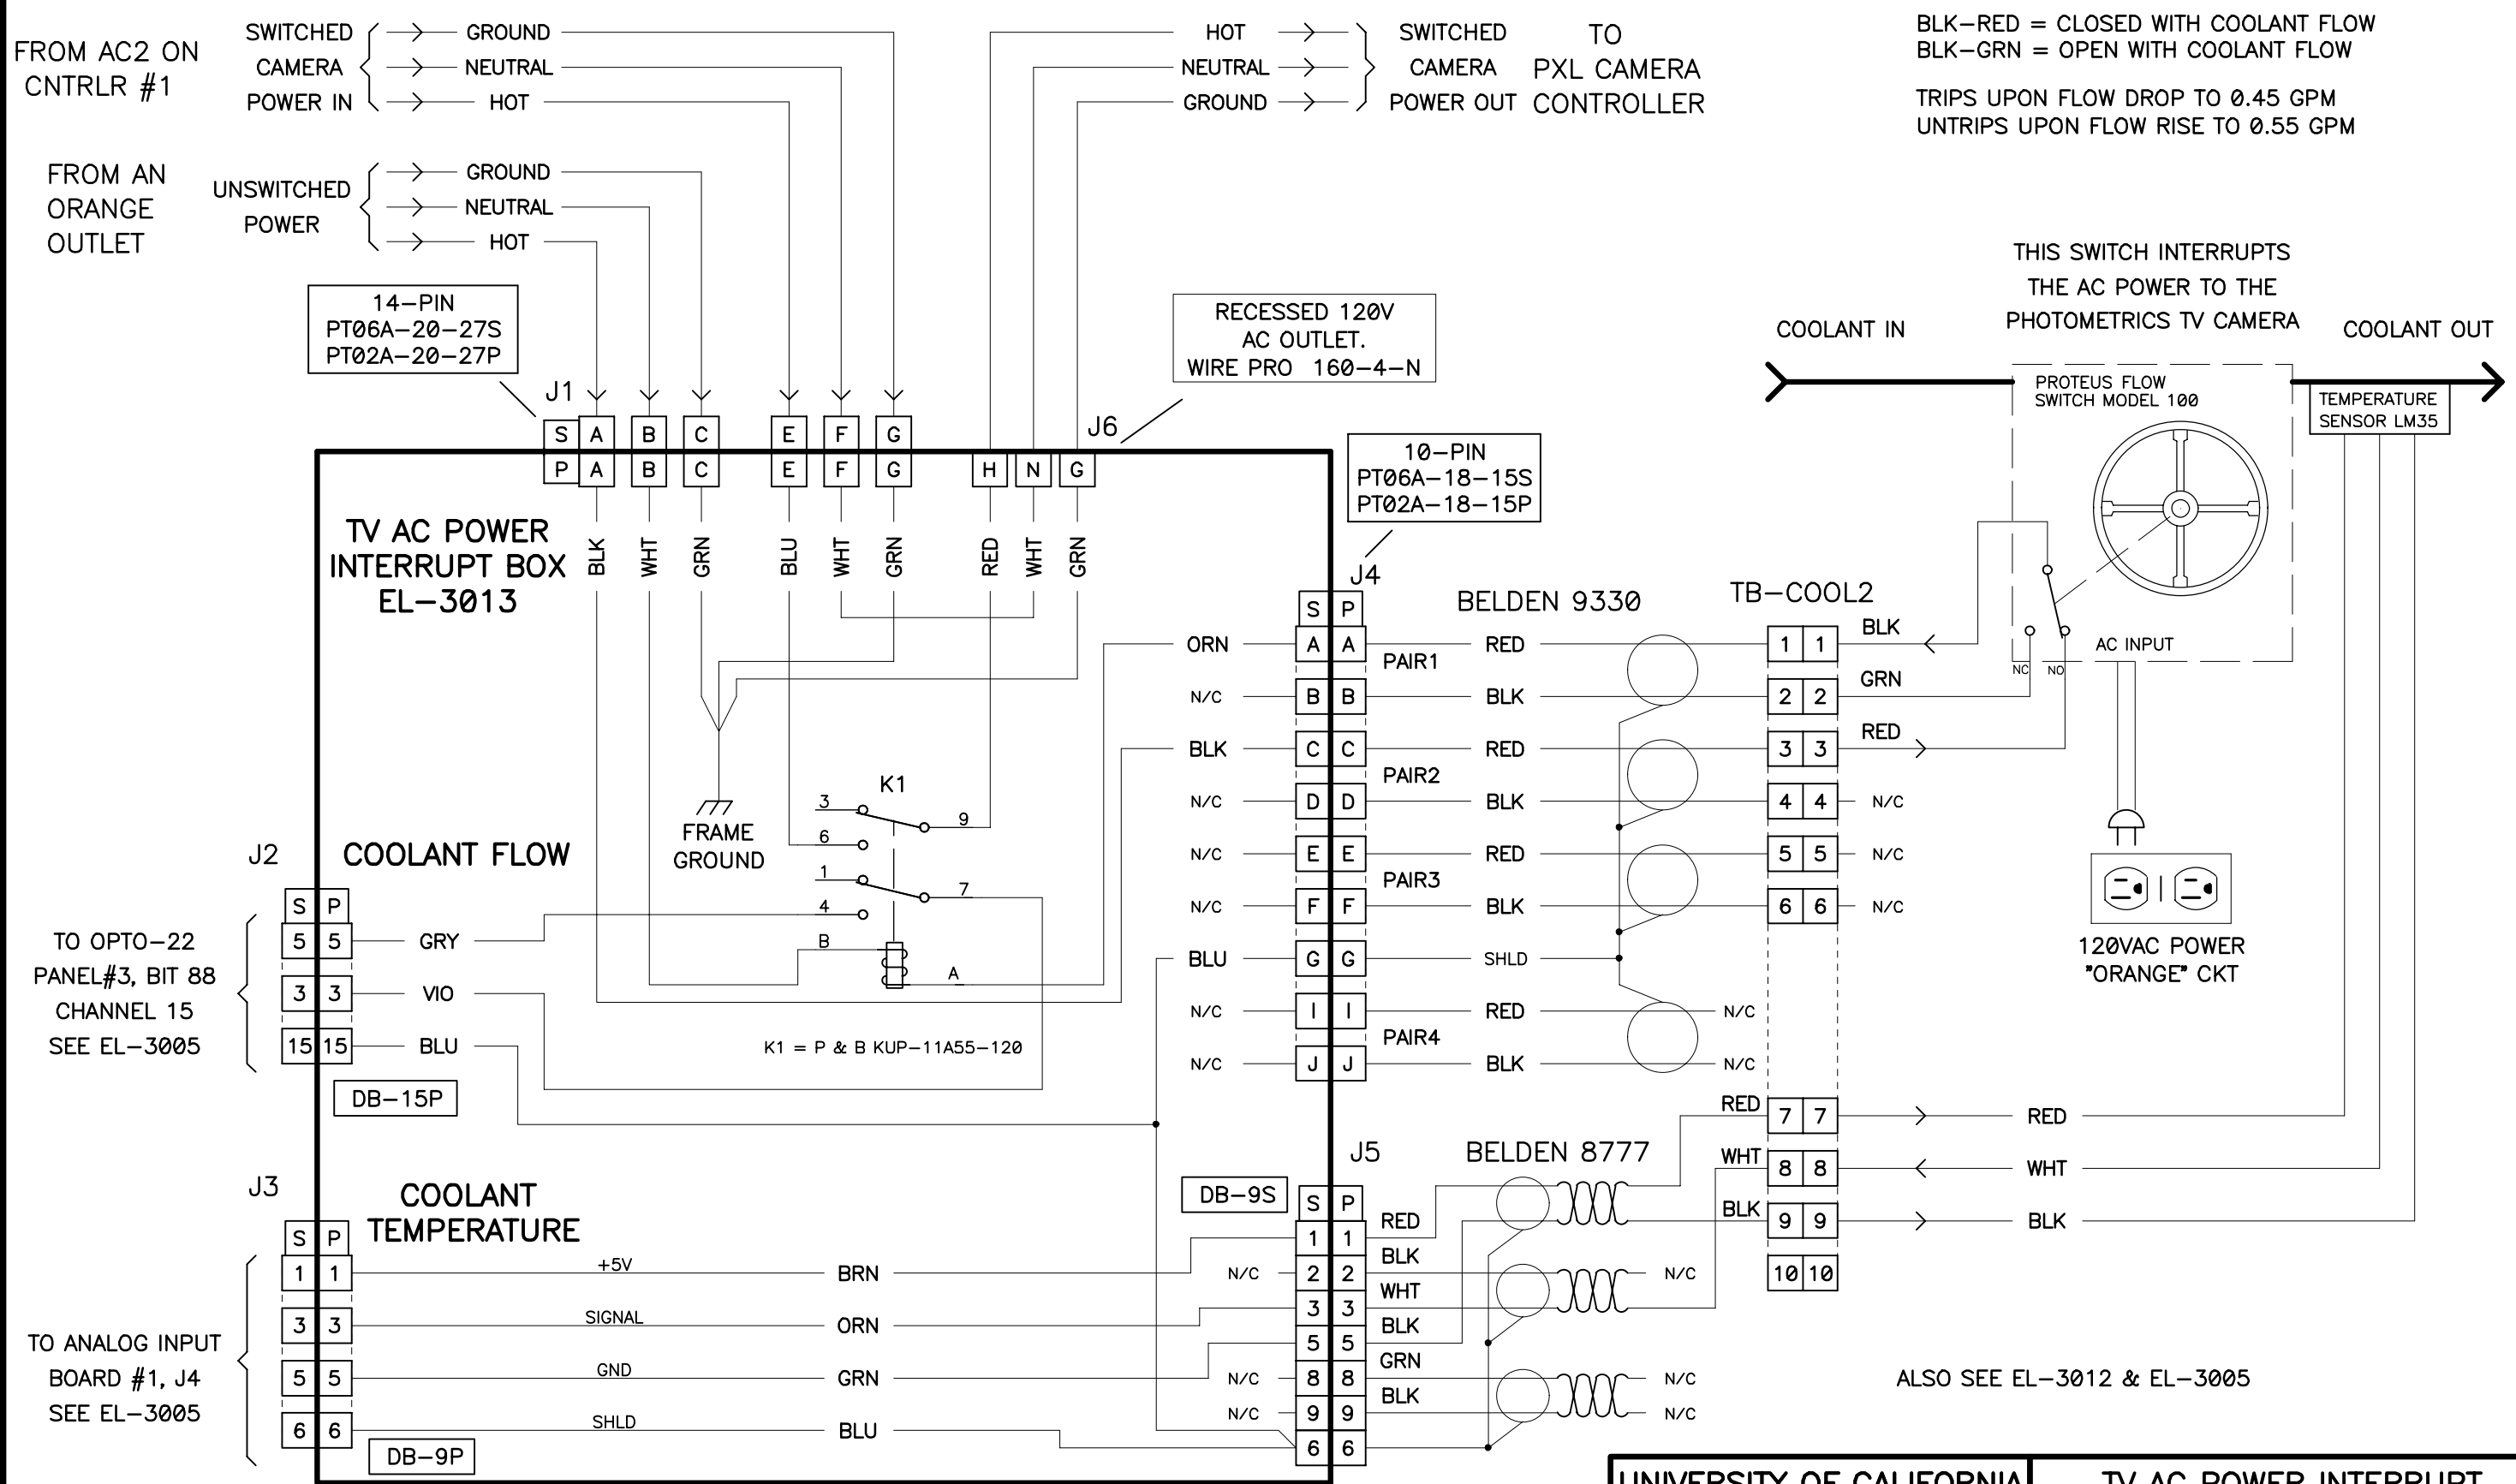
REVISION	
05-22-01	UPDATED SCHEMATIC WITH NEW EL-3013 BOX TO HOUSE THE SOLID-STATE RELAYS
07-11-01	ADDED WIRE DETAILS
08-22-01	CORRECTED CONNECTOR DETAILS
08-23-01	REPLACED 2 SOLID STATE RELAYS WITH 1 CONVENTIONAL RELAY
08-30-01	REMOVED AC WIRES GOING THROUGH BOX AT J4,D&E TO PROTEUS FLOW SWITCH. CORRECTED PIN NUMBERS ON RELAY.
09-17-01	ADDED FLOW SWITCH CALIBRATION AND CONTACT INFO AND CORRECTED K1 PIN NUMBERS.
